Midpoint Project Status Report
SMECO/Navy PEM Fuel Cell Demonstration
Contract #DACA42-02-C-0003

Site No. 1 and Site No. 2
Patuxent River Naval Air Station
Patuxent River, Maryland

March 03, 2003

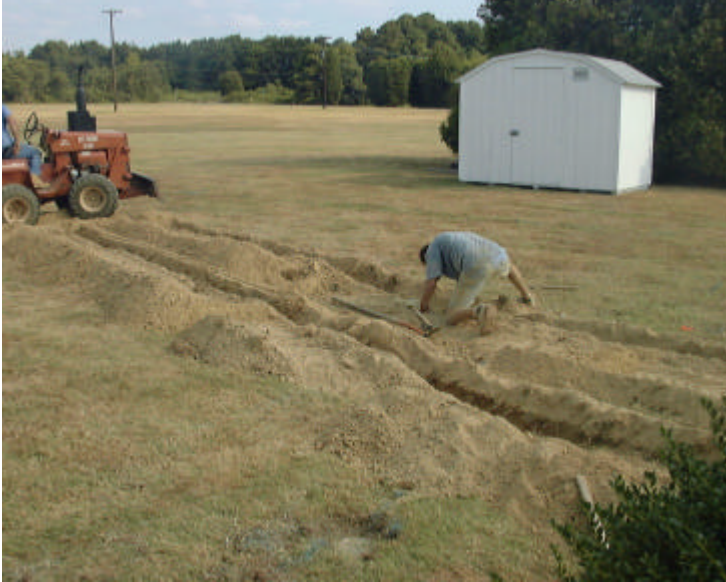
Trenching across the yard

✍️ One trench was provided for the natural gas pipe leading from the house gas main to the fuel cell pad.

✍️ The other trench was for power and control wiring, supply and return co-generated hot water, and the de-ionized feed water.

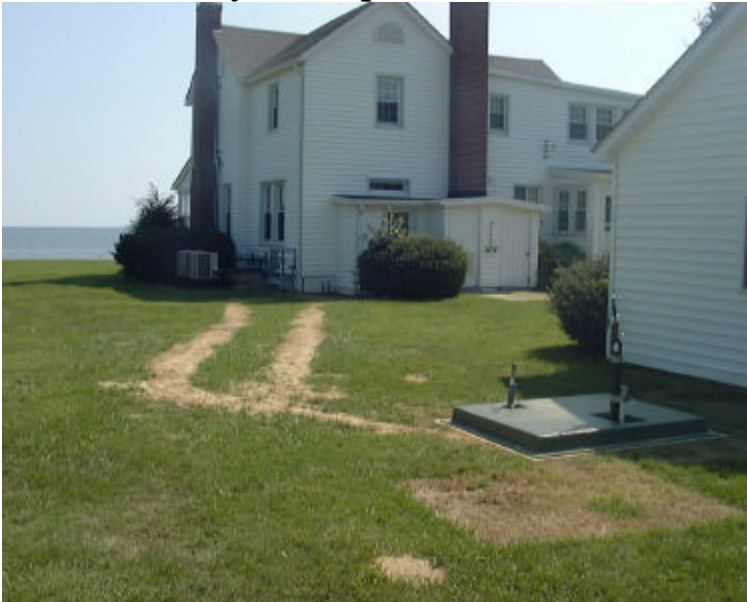
Pad with utility stub-ups

✍️ Pad was installed on pressure-treated 6x6 timbers, all resting on a six-inch-thick gravel bed.

✍️ The required nitrogen for purging the fuel cell was piped underground from a canister located in the garage, just to the right of the pad.

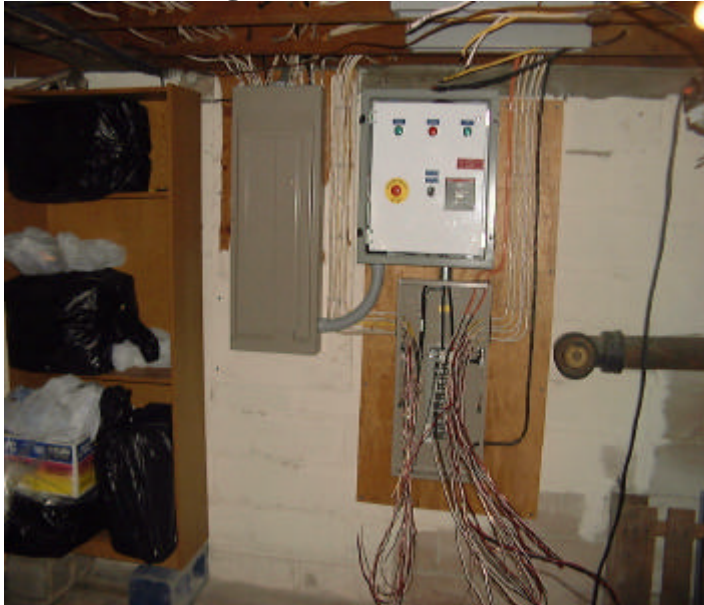
Interior wiring with transfer switch

- Initially all building loads were relocated to the sub-panel served by the fuel cell transfer switch.*
- Fuel cell battery charger and fuel cell onboard emergency heater were served exclusively from the grid-supplied panel.*
- The transfer switch had an emergency shut off button enabling the residents to quickly shut down the unit.*

The sub-panel circuits supported by the fuel cell automatic transfer switch are as follows:

- ~~Interior and exterior lighting~~
- ~~Refrigerator~~
- ~~Dishwasher~~
- ~~Television~~
- ~~Natural gas boiler and circulator pumps~~
- ~~Clothes washer~~
- ~~Clothes dryer (electric)~~
- ~~Microwave~~
- ~~Wall receptacles~~
- ~~Personal computer system~~

Excluding the boiler, the above appliances represent the baseload appliances year round. When we enter the cooling season, we have not decided as of yet whether we will stay with the same connection scheme or rotate most circuits back to the grid-only panel and attempt to support the central air conditioner. Due to the lifestyle of the occupants, one particular day of the week became a peak usage day. The clothes dryer was used extensively during this period, which taxed the load carrying capabilities of the fuel

cell's onboard batteries. When the fuel cell switched back to grid, in response to the overload, the dryer logic control would be disrupted and turn off the dryer. The fuel cell would then see the load reduction and switch back to PEMFC operation. Later in the day the occupants would find out their clothes were not dry and in response turn the dryer back on. Resulting in the whole cycle being repeated. After several frustrating weeks of this, we switched the dryer load back to grid, thus eliminating the problem. The power use profile of this residence turned out to be a stressful one for the PEMFC. For many hours the load would only be about 400 to 600 watts, which was too low for continuous operation for the stack and onboard processes. With loads that low, the PEMFC was consuming more energy to maintain onboard operations than the loads placed on it. Our solution was to provide two 1,200-watt portable electric heaters to heat an unheated enclosed sun porch. The occupants operated the heaters when they were not home or during low appliance use. This provided a steady load on the PEMFC and improved its operational efficiencies. It also provided a more comfortable sun porch, which was very much appreciated by the occupants. During occupied periods, the load ranged between 2.5 kW to 4.0 kW on average. During unoccupied periods (with the electric heaters operating) the load ranged between 1.5 kW to 2.5 kW. When the heating season ends, and before air conditioning starts, we will use the portable heater(s) to dry out the basement.

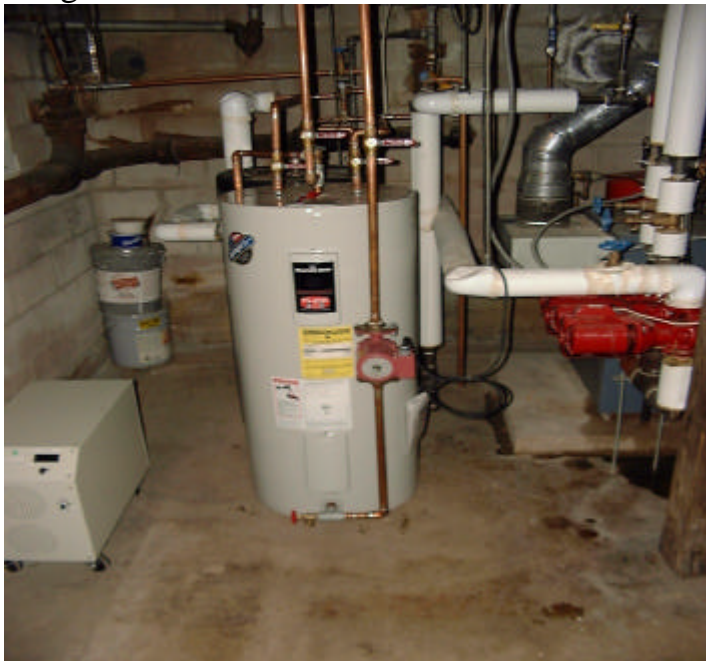
Co-generated hot water tank

- ✍✍ This vessel served as a preheat tank for the domestic water heater.
- ✍✍ The circulating pump operated at a 3.5 gpm flow rate.
- ✍✍ This was an open loop design using potable well water at 55 degrees F.
- ✍✍ Preheated water entered the main water heater tank at temperatures above 125 degrees F.

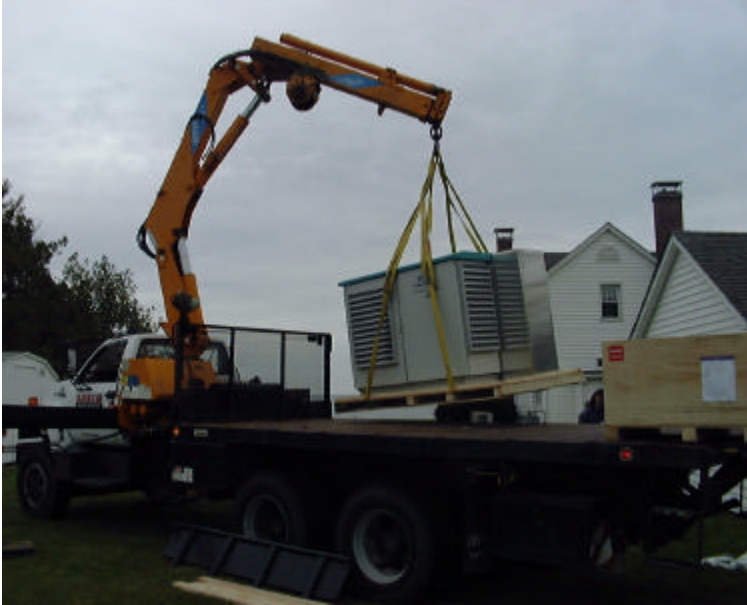
Fuel cell off loaded by boom truck

- ✂✂The H-Power RCU-4500 fuel cell weighs about 3,100 pounds, requiring a boom truck to safely lower the unit on the pad.
- ✂✂Once lowered on the pad, all plumbing and wiring connections are made in a relatively short time.

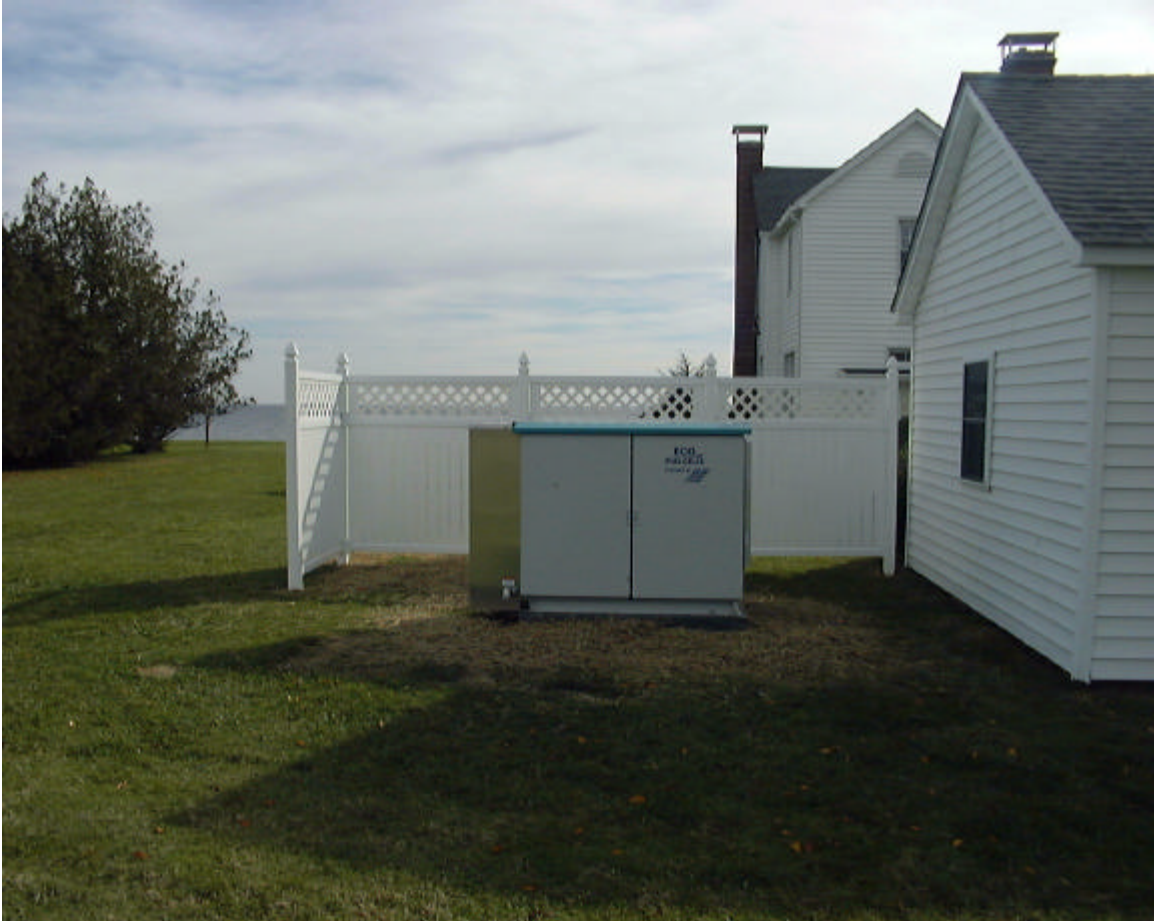
Installation complete at Site No. 1

Note 1: During initial set-up procedures, the fuel cell took much longer to achieve proper operating temperatures due to cold winds blowing off the Chesapeake Bay. H-Power engineers felt a wind fence would resolve the problem. The fence indeed had a positive impact on reducing start-up time. On later occasions, and in much colder weather, fuel cell start up occurred within normal operating time frames.

Note 2: The large nitrogen canister for system purge requirements is located in the small building just to the right of the fuel cell. The nitrogen supply tube runs underground in a plastic conduit from the garage to the fuel cell pad.

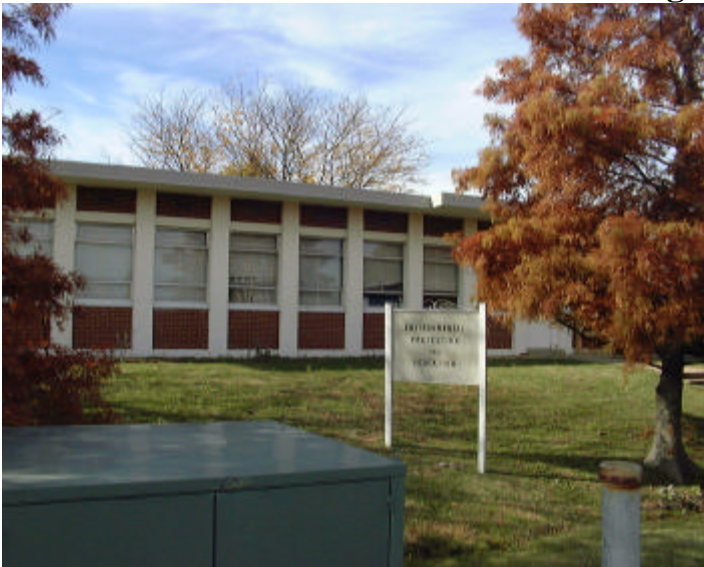
View of the PRNAS Conservation Building

- ✍️ *The base Environmental Protection and Conservation building was selected for its easy access by the public and load requirements suitable for the 4.0 kW fuel cell.*
- ✍️ *Site was also suitable for propane storage and a co-generated heating application.*

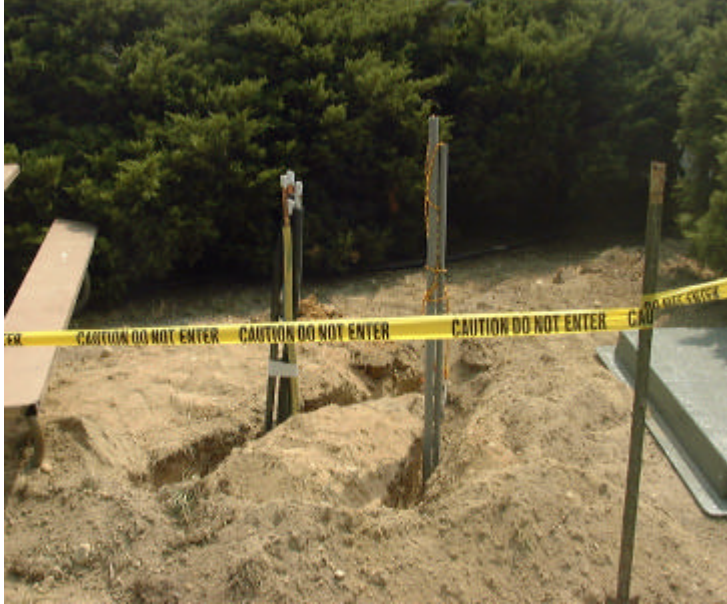
Trench and stub-ups prior to pad installation

- ✍️ *Here the stub ups for all connections are easily seen.*
- ✍️ *This area is open to the general public and had to be fenced off and covered each night for safety.*
- ✍️ *After backfill, a 6-inch gravel base was added and a 6x6 timber foundation installed.*

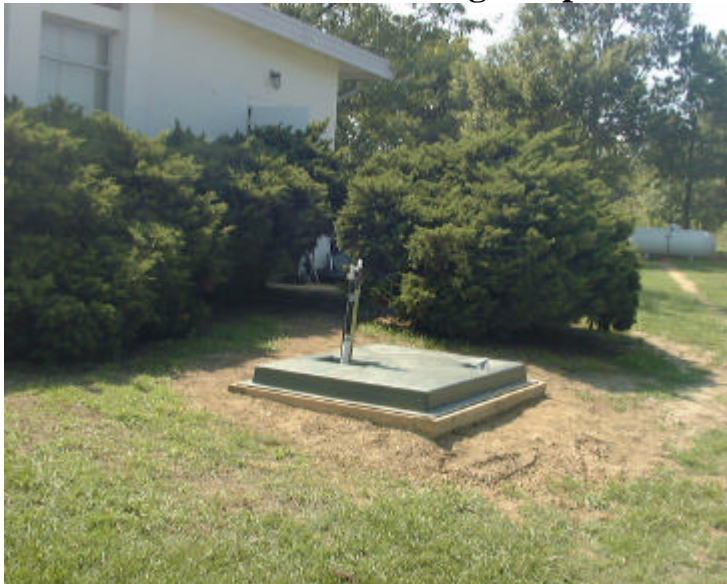
Pad installation and trenching complete

- ✍️ *The 6x6 foundation has been installed and the pad securely attached.*
- ✍️ *All trenching and backfill work complete.*
- ✍️ *Notice the trench leading from the 500 gallon propane tank 70 feet from the fuel cell location. Propane for the fuel cell is provided at a 20 psi pressure level.*

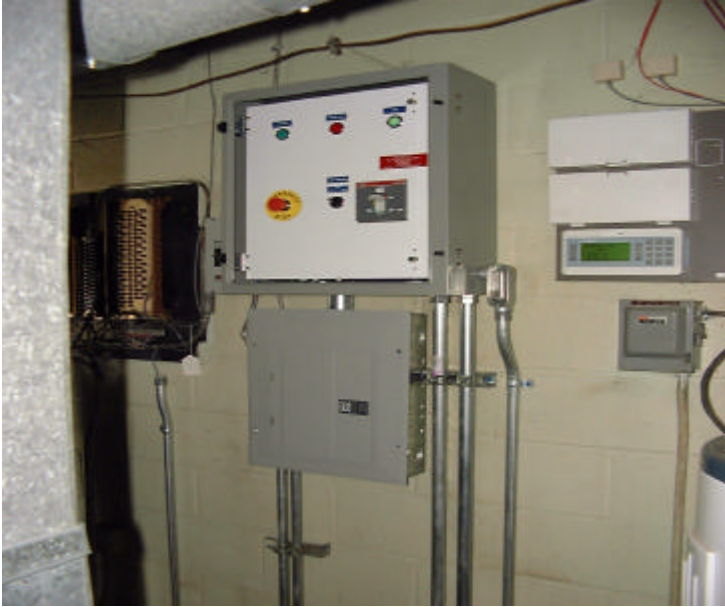
Fuel cell transfer switch and sub-panel

✍✍ The equipment room is located 15 feet from the fuel cell location with easy access for public viewing during planned educational programs.

✍✍ Being a commercial building, all power and control wiring required proper conduits and support.

The sub-panel circuits supported by the fuel cell automatic transfer switch are as follows:

- ✍✍ Building interior lighting
- ✍✍ Nine desk-top computers
- ✍✍ Animal display life support systems
- ✍✍ Oil forced air furnace
 - Blower and burner in winter
 - Blower only in summer

The average load is between 3.0 and 3.5 kW, which is an ideal load for the fuel cell stack. Even better is that being a commercially operated building, the energy load is relatively consistent eight to ten hours per day. This consistent 75 to 80 percent stack loading maximizes fuel cell stack efficiency and reduces internal processing stresses according to H-Power. During the summer cooling months, some rotation of circuits are planned. This will prevent fuel cell stack overload due to the anticipated air conditioner loads.

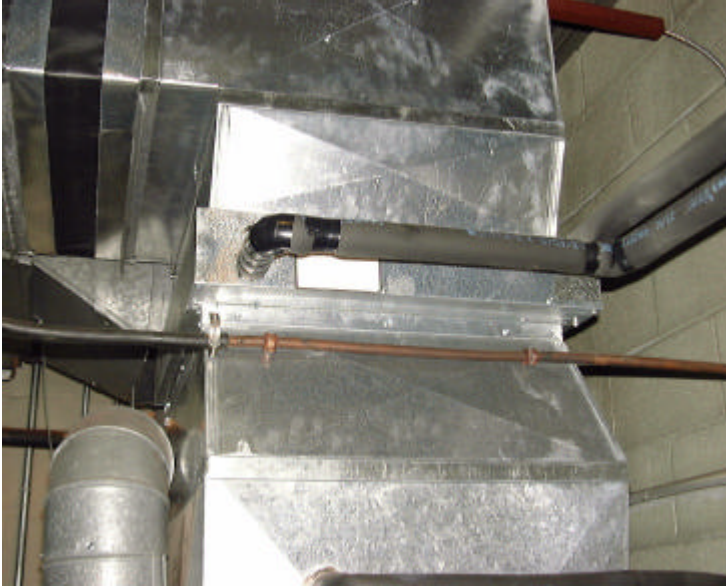
Co-generated heat exchanger attached to furnace

- ✍️ A hot water coil was installed into the supply-side plenum of the oil furnace.
- ✍️ Co-generated hot water collected from the fuel cell stack would circulate through this coil via a circulating pump with a 3.8 gpm flow rate.
- ✍️ A two-stage thermostat wiring control was to provide proper heating control between the hot water coil and furnace output.

The base HVAC contractor installed a two-stage thermostat to provide proper control as to what heat source would heat the building as a function of the structure's heating requirements. Site No. 2 fuel cell installation was engineered to expose the fuel cell to a steady load requiring a 75-to 80-percent stack output during business hours. This loading scheme generates a nominal 22,000 Btu's per hour of available co-generated heat. The circulator pump is powered by the fuel cell (no grid connection) via a line voltage relay off the first stage thermostat. When the first stage is activated, the furnace blower and circulator pump are energized, allowing co-generated hot water into the plenum-inserted heat exchanger. Should the heat output be insufficient, the second stage would engage igniting the oil burner and disengage the circulator pump. We discovered during a very cold weather period that the second-stage mode-wiring scheme did not de-energize the co-generated hot water loop circulator pump as assumed.

We determined that whenever the ambient outdoor temperature was above 45 degrees Fahrenheit, the first stage heat (fuel cell co-generated Btu's) satisfied the building heating requirements exclusively. Generally, below 45 degrees the second stage would engage due to a three-degree drop in building temperature below the first stage setting. The thermostat would cycle between first and second stage until outdoor temperatures rose above 45 degrees again. The average winter temperature at PRNAS is 42 degrees Fahrenheit making this a good location for this type of application. Recorded first-stage heat output (fuel cell co-generated output measured in

the supply air stream) averaged around 106 degrees Fahrenheit. The return averaged around 75 degrees Fahrenheit for a delta temperature rise of 31 degrees. That is a respectable heating performance output from the fuel cell. When we witnessed Stage Two operations and the fuel cell was at full load conditions, the hot water heat exchanger still rejected heat into the supply air stream. It is assumed, though, that during non-business hours when the fuel cell is at minimal load conditions (low co-generated heat output) and the furnace is in Stage Two operation, the co-generated hot water coil is probably absorbing heat. The plus side of this is that the loop fluid was always in motion and kept above freezing temperatures. This is important since the co-generated water loop enters the building three feet above grade. A site-built metal covering protects the above-grade pipes, however the covering is poorly insulated. This winter we experienced colder than normal temperatures over many days. Without the accidental design flaw, we may have suffered some flow problems during the extreme weather.

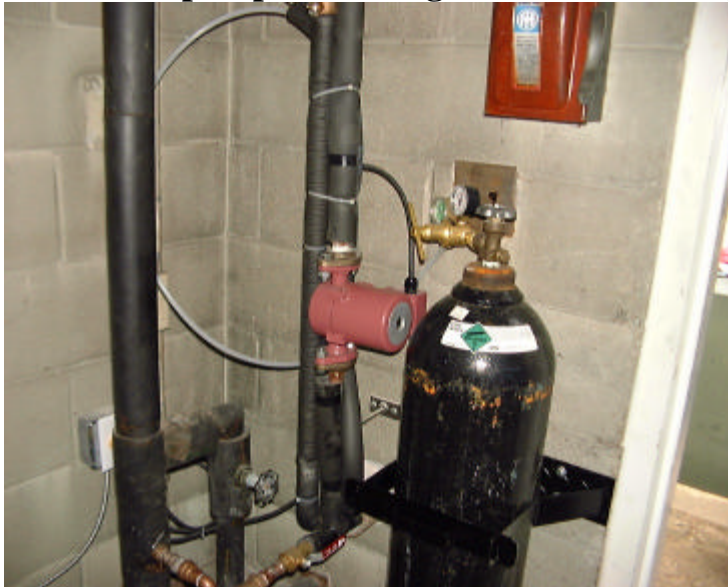
Circulator pump and a large canister of nitrogen

- ✍✍ In the center of the picture is the co-generation water loop circulator pump. The flow was measured at 3.8 gpm.
- ✍✍ The large black canister is filled with nitrogen used to purge the fuel cell when in shut down or start up.
- ✍✍ The nitrogen is supplied to the fuel cell via a plastic hose buried in the utilities trench leading to the fuel cell pad.

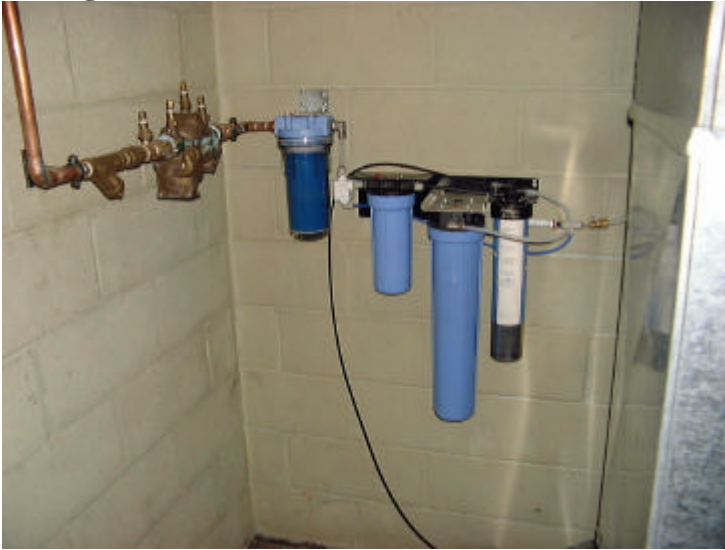
Culligan feed water filter and de-ionizer

- ✍️ To the left of the first stage filter is the EPA required back-flow valve. This is required to prevent a contamination of the public water supply by the fuel cell via the feed water connection.
- ✍️ The de-ionizer must maintain a conductivity less than 1.0 microsiemen. This must be checked every 6 months.

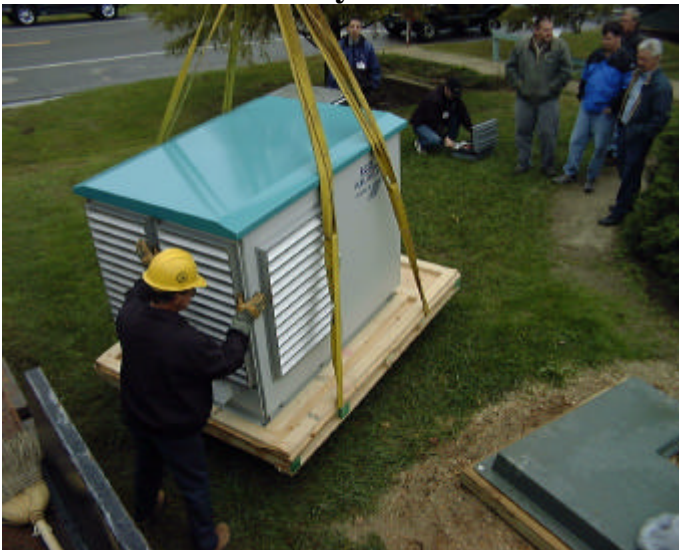
Fuel cell off loaded by boom truck

- ✍️ Pad is securely attached to wood foundation and ready for fuel cell attachment.
- ✍️ The boom truck proved to be the best way to maneuver the 3,100-pound fuel cell on to the pad and stub-up connections without damaging them.

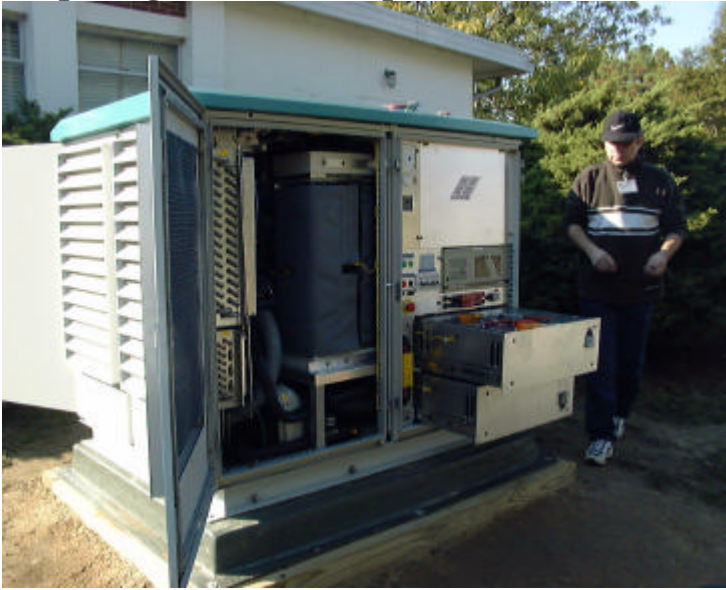
Preparing fuel cell for operation

- ✍️ A technician prepares the fuel cell by connecting all wiring and plumbing connections.
- ✍️ The two drawers pulled out on the lower right of the fuel cell are the load-carrying on-board batteries.
- ✍️ All connections were made in less than four hours.

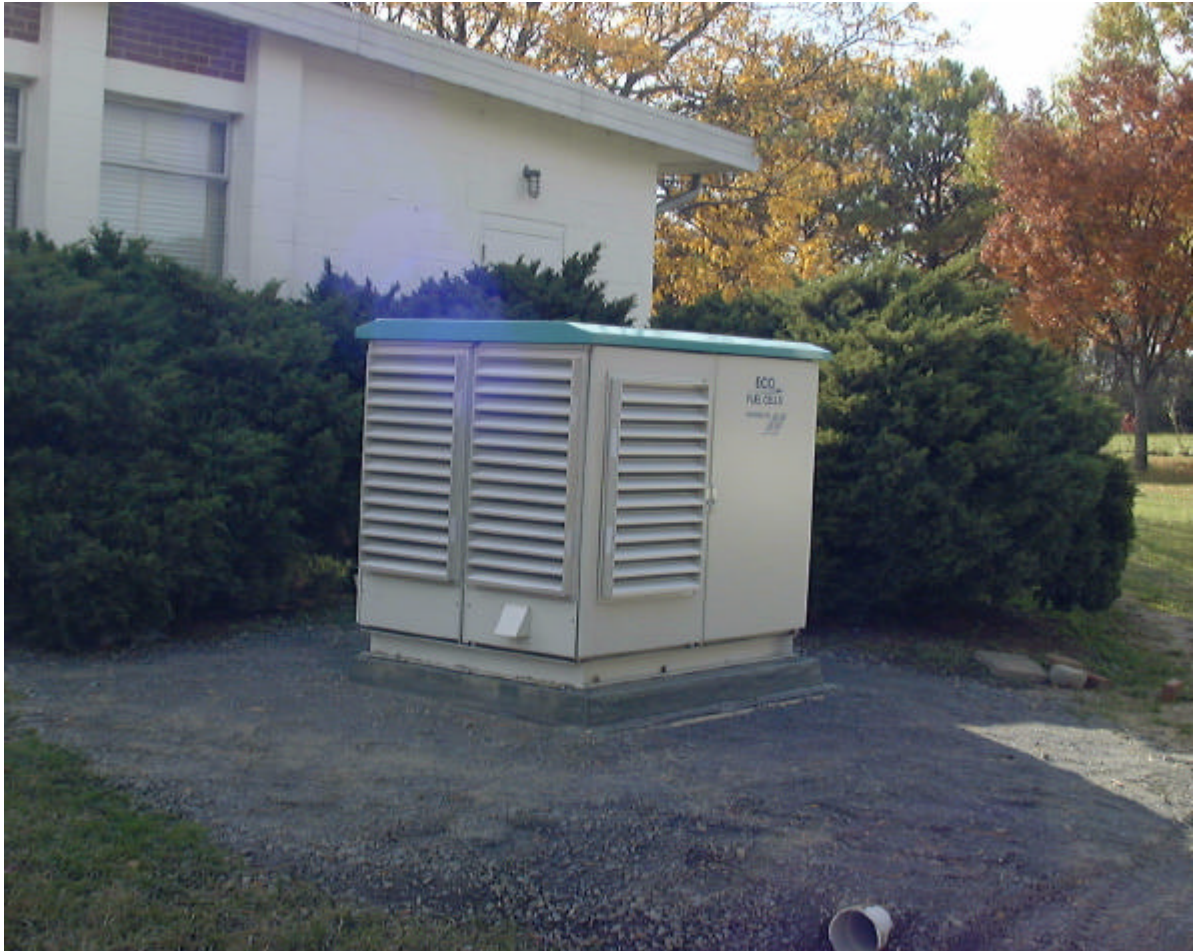
Finished installation at site No. 2

The propane unit was fully installed and running in less than two days. This unit was not subject to high wind conditions, thus a fence was not required. We had gravel spread around the unit to accommodate the many footprints of onlookers. The drainpipe was installed to facilitate proper drainage around the gravel base. It is a short fifteen feet to the equipment room located just behind the door under the lamp on the building wall. This provides safe and easy access for guided tours to illustrate the co-generation connections, automatic transfer switch, battery charger, and feed water de-ionizer. There is also ample parking for cars and buses. This is truly a good site for public display. Once we feel confident in the fuel cells' operational reliability, we plan on announcing a regular open house schedule.
